CERTIFICATE OF APPROPRIATENESS

Property: 412 Main Street Tracts 2A and 3A, Block 44, SSBB Subdivision, City of Houston, Harris County, Texas. The site includes a 13-story steel frame building situated on a 4,626 square foot lot.

Proposal: Alteration – Remove the existing historic, heavily damaged cornice above the 12th floor and replace it with smooth EIFS scored to look like masonry.

412 MAIN BUILDING EAST PARAPET REPAIR

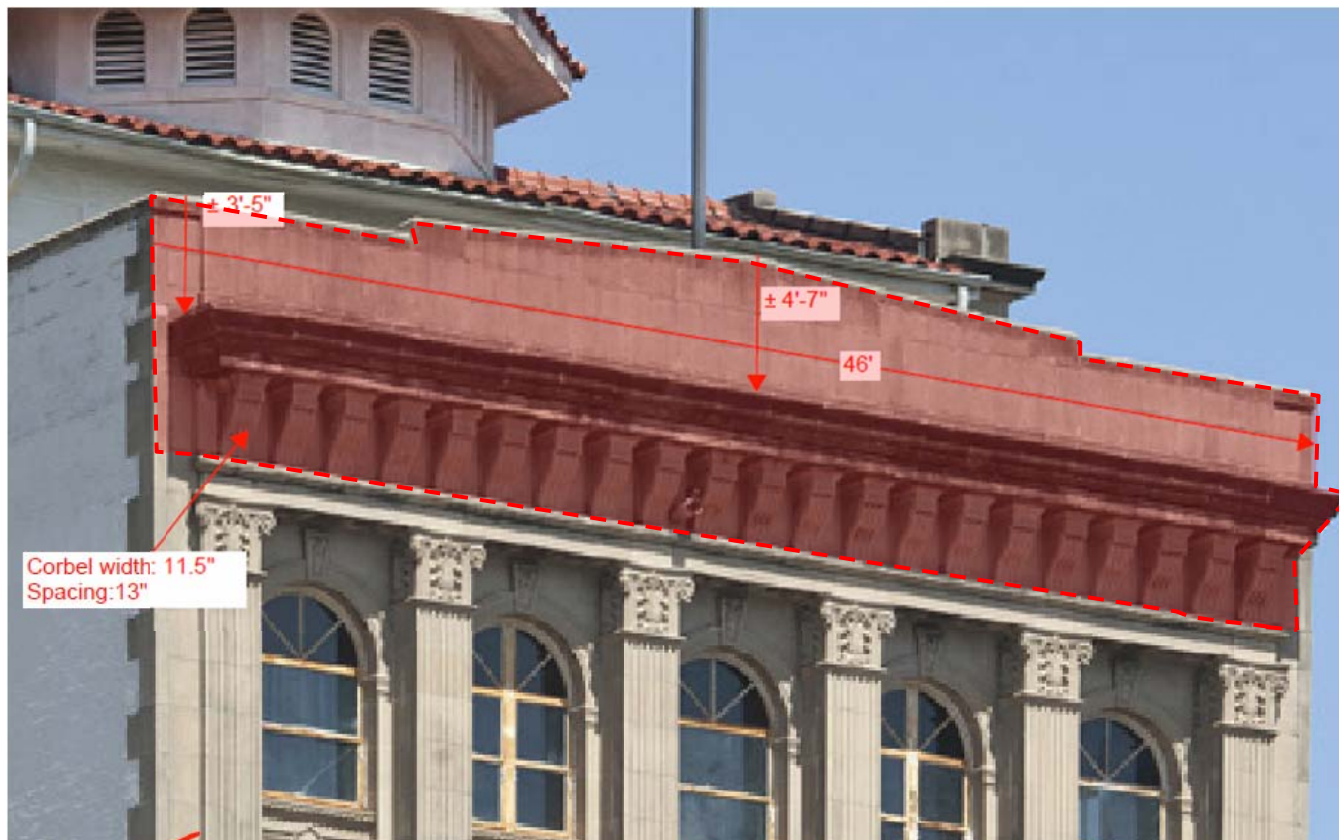
PORTION TO BE REMOVED

Front Elevation: The alteration removes an approximately 8' to 9'-5" tall section of damaged stone cornice and
(East) replace with smooth EIFS scored to look like masonry.

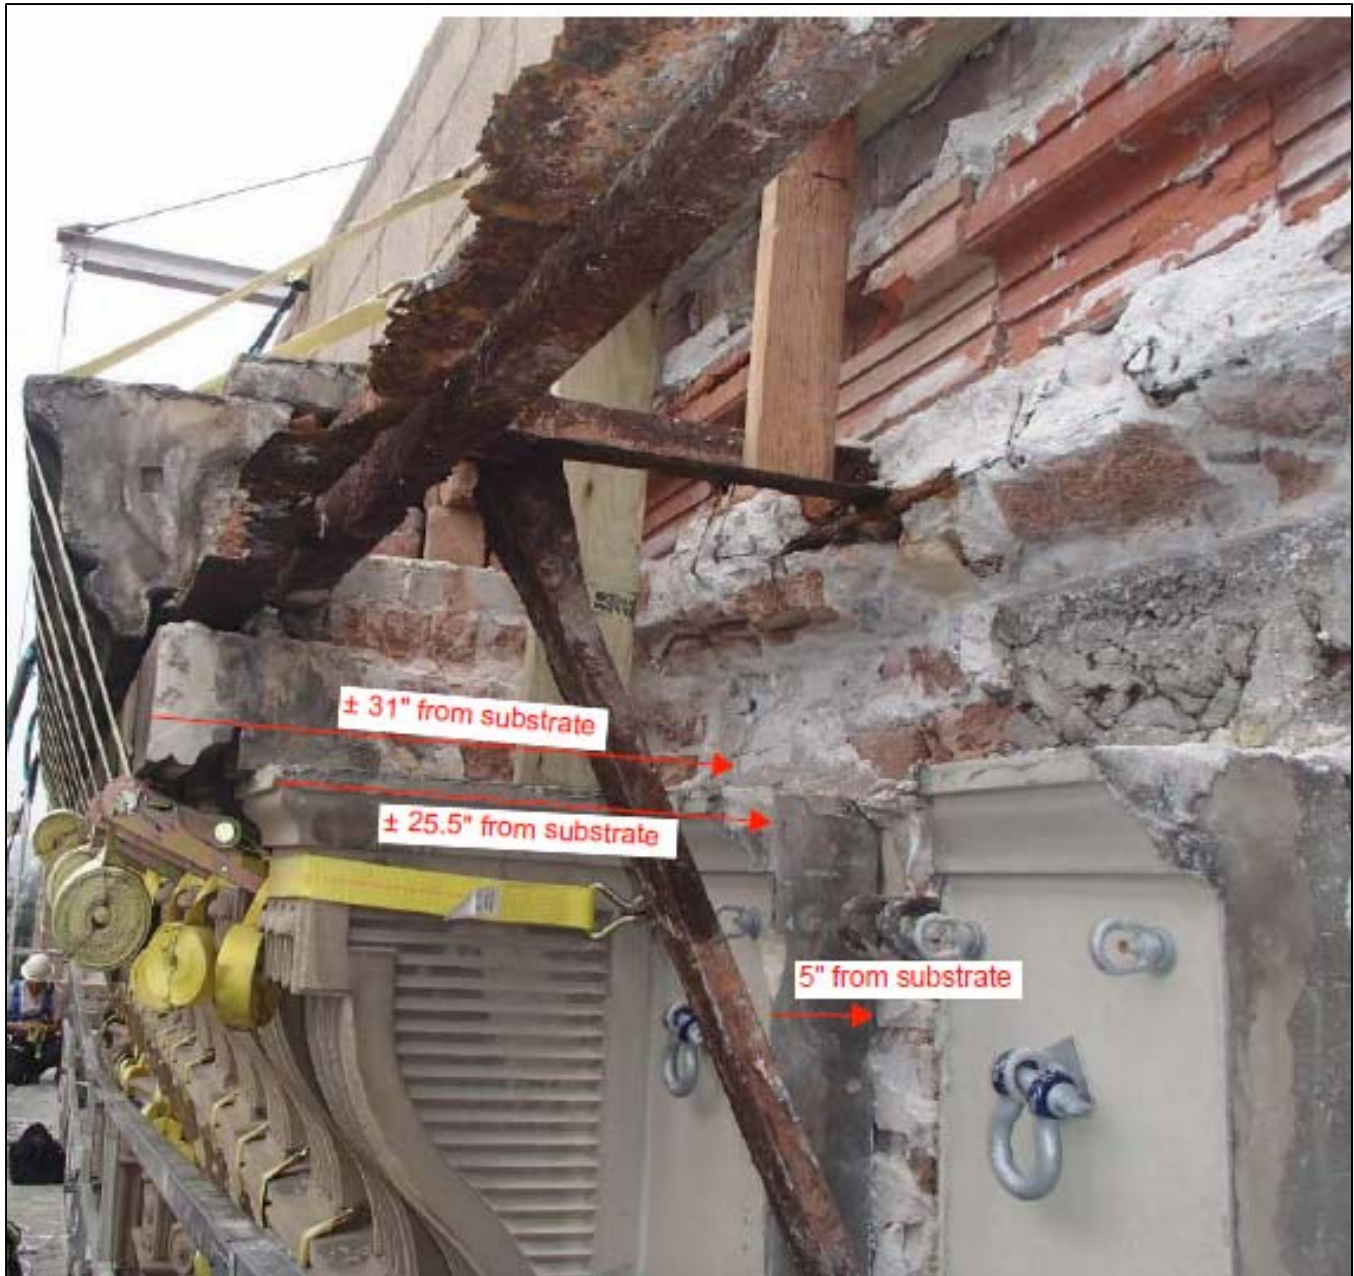
EXISTING CORNICE CONDITION – RUSTED BRACING

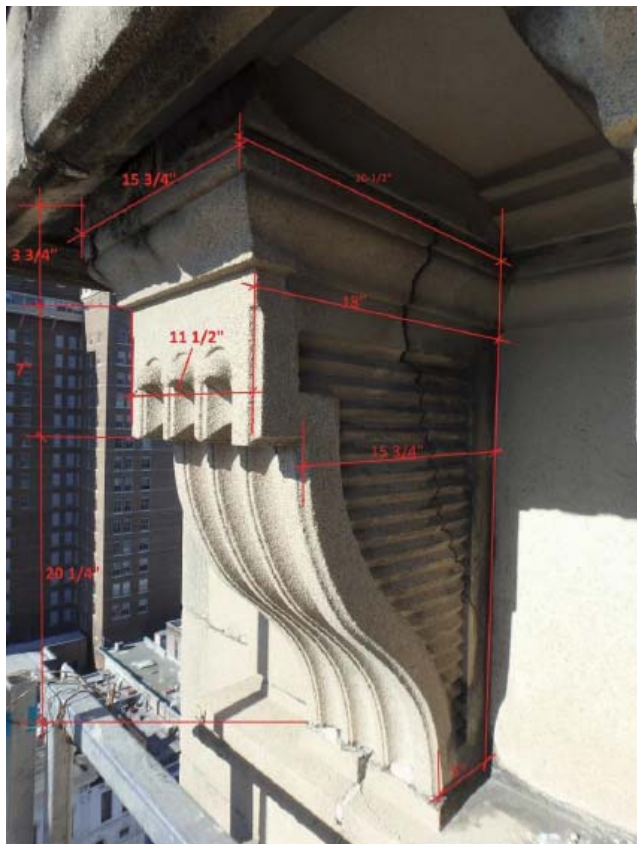
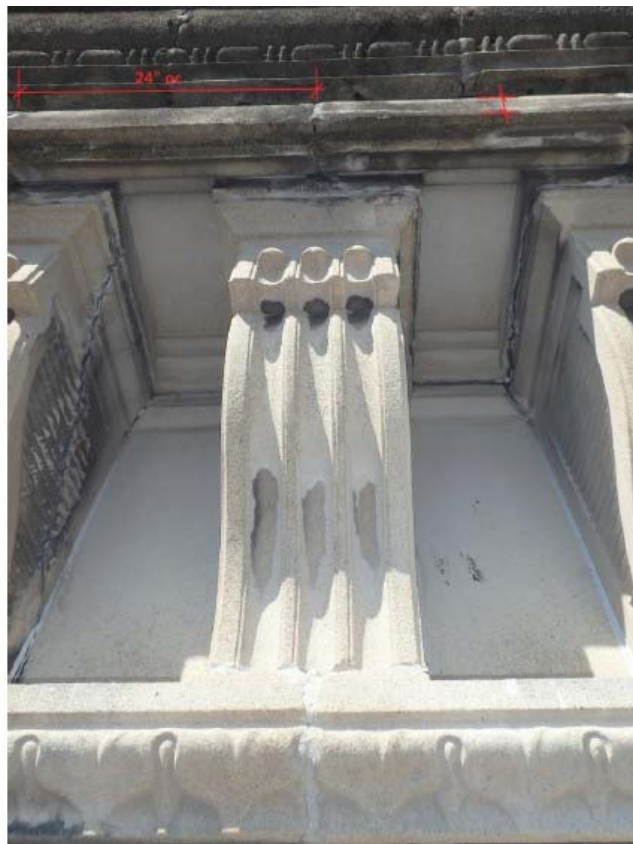
EXISTING CORNICE CONDITION – SHEERING STONE WORK

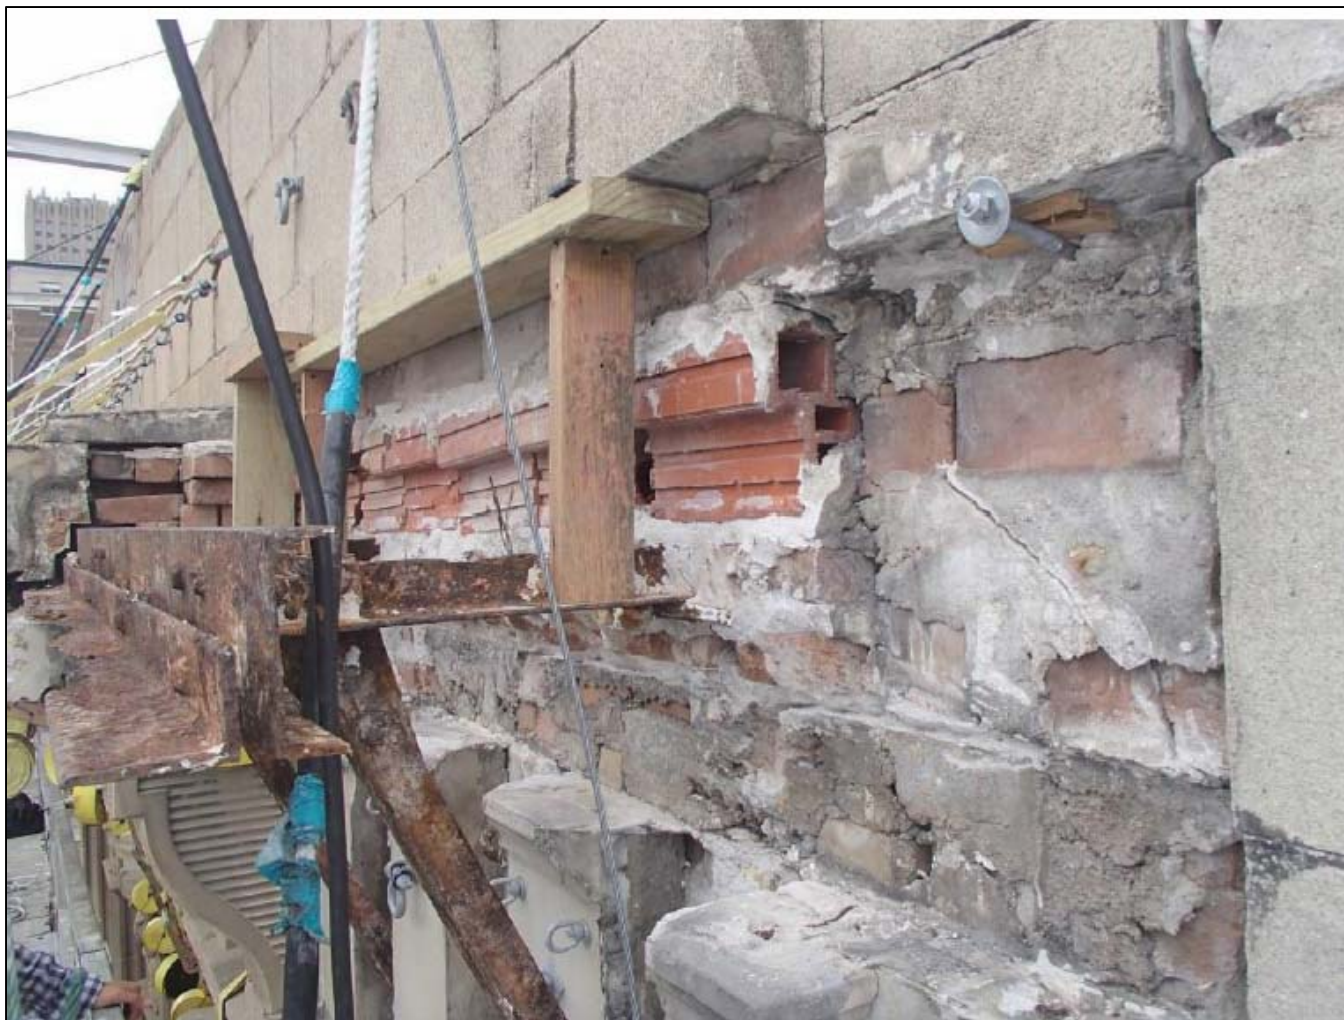
EXISTING CORNICE CONDITION – SHEERING STONEMASONRY

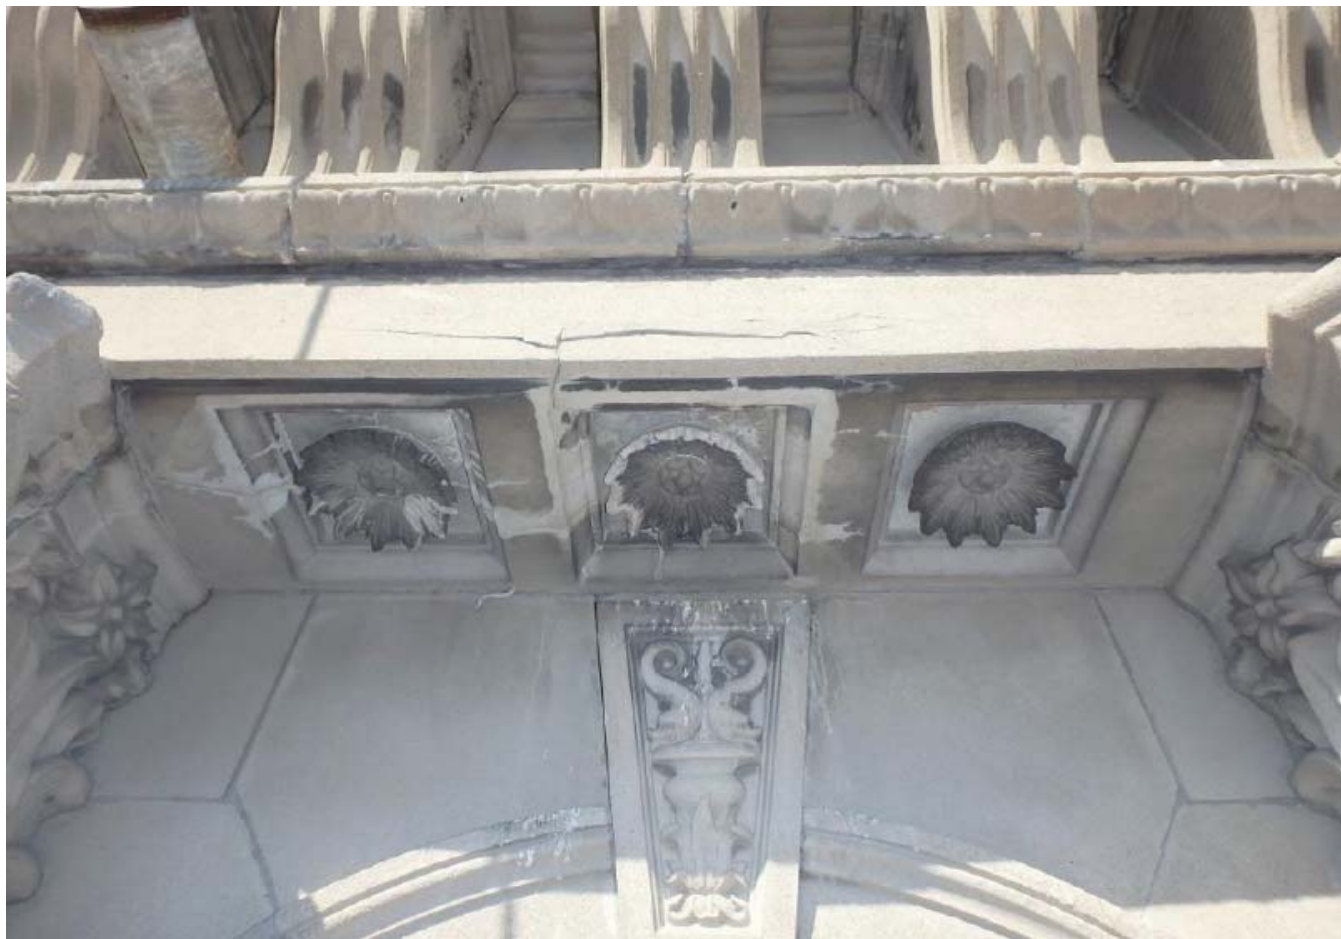
EXISTING CORNICE CONDITION – CRACKING STONEWORK

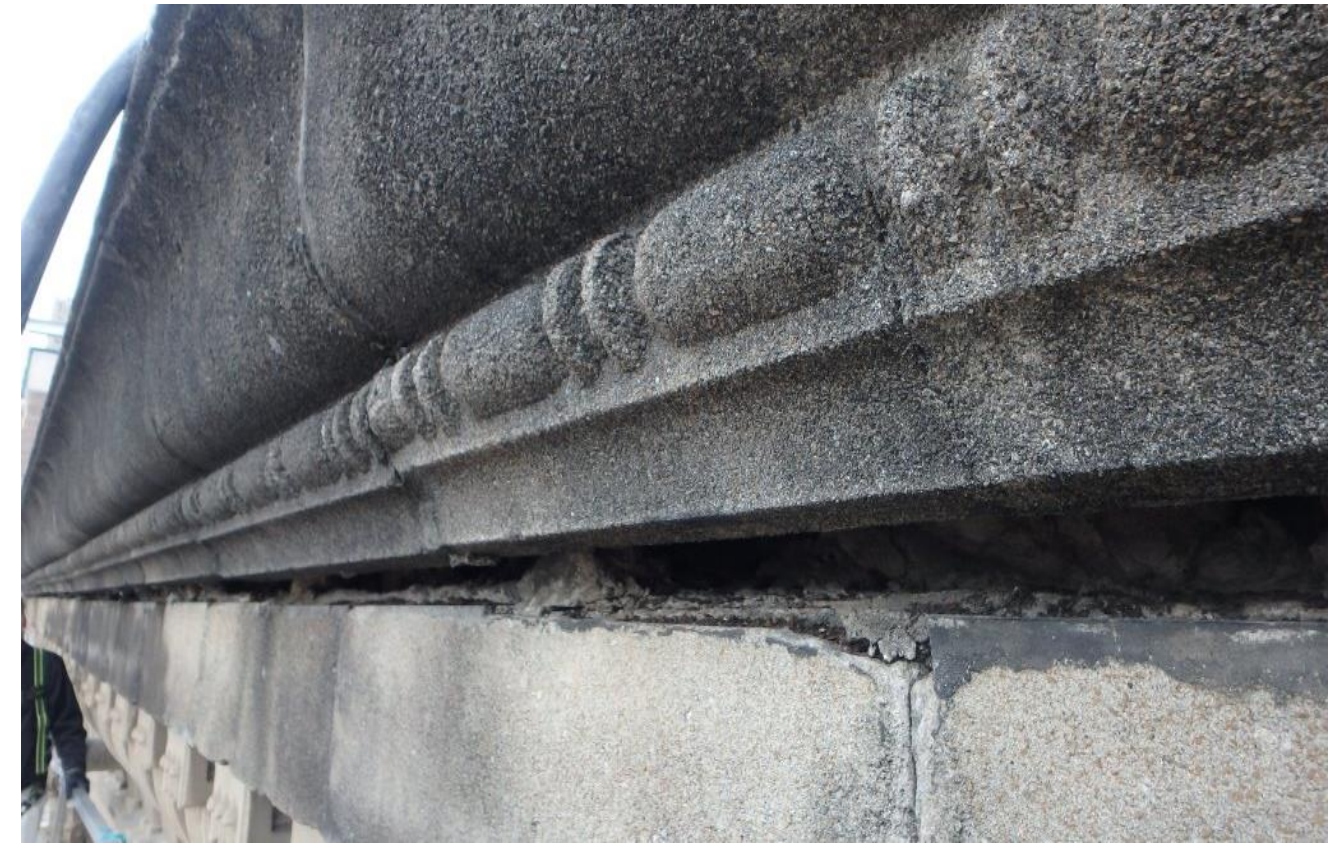
- Upper cornice cast stone pieces generally exhibiting displacement and mortar joint separation, likely due to corrosion-related expansion stresses.
- Most significant distress conditions were observed at the eastern and western upper corner cast stone members.

Upper cornice layer exhibiting joint separation

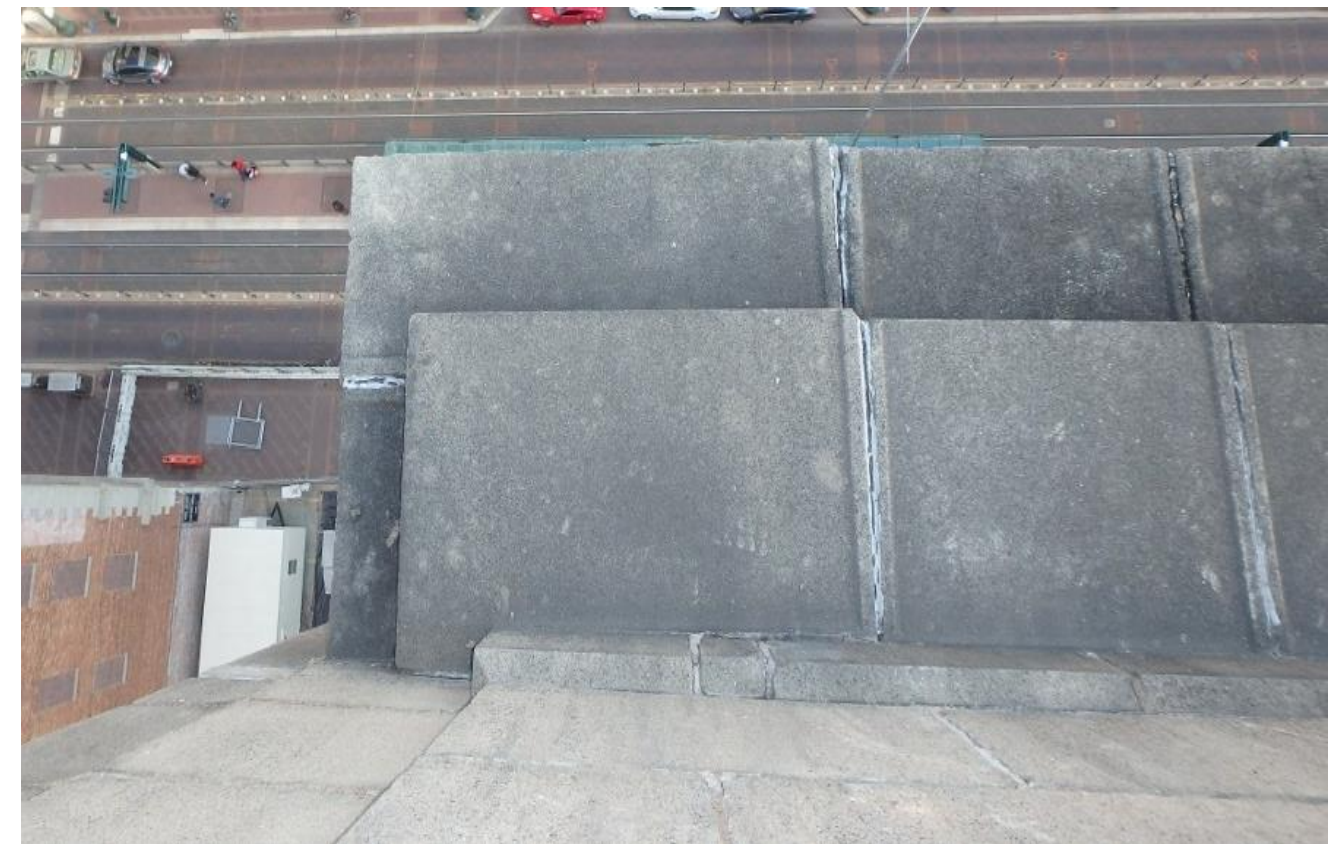
Cornice stone pieces exhibiting lateral displacement

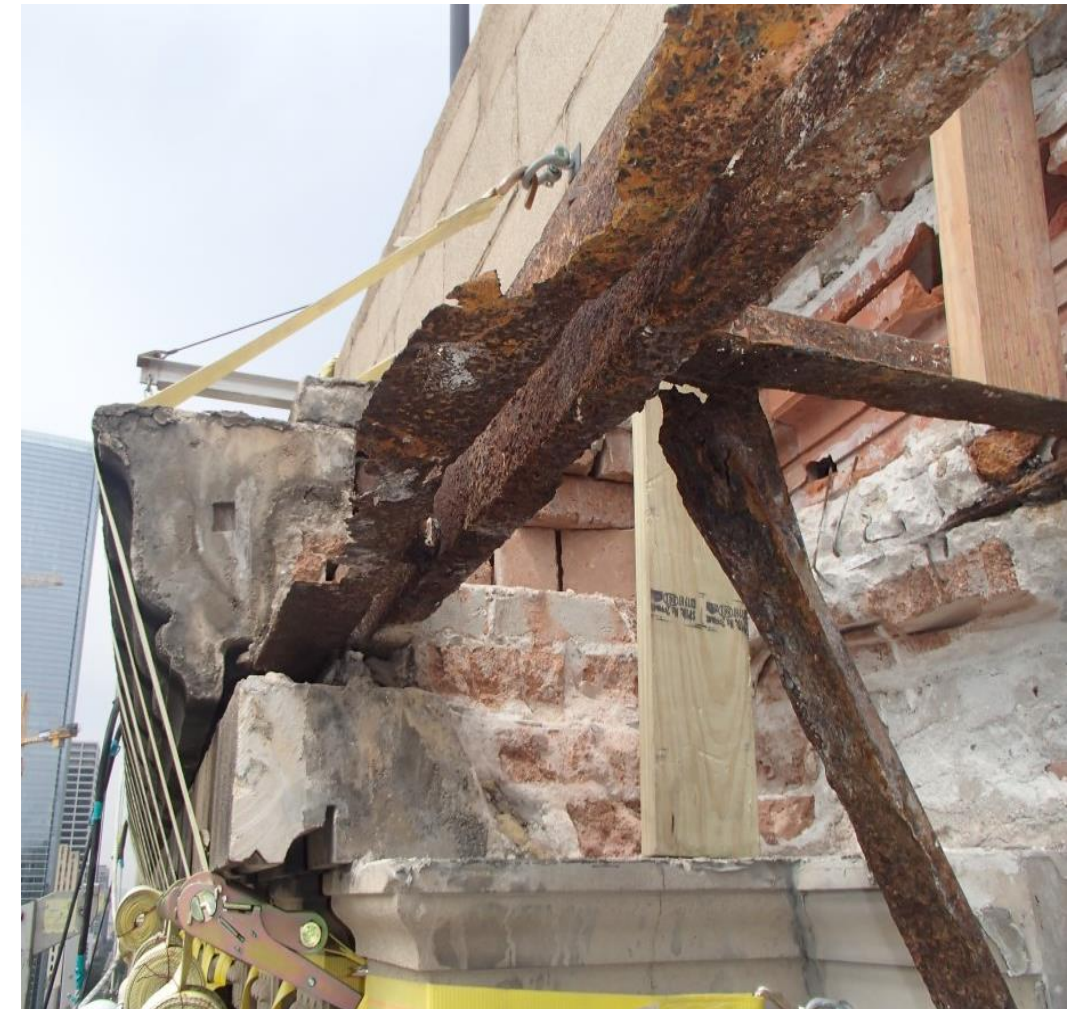
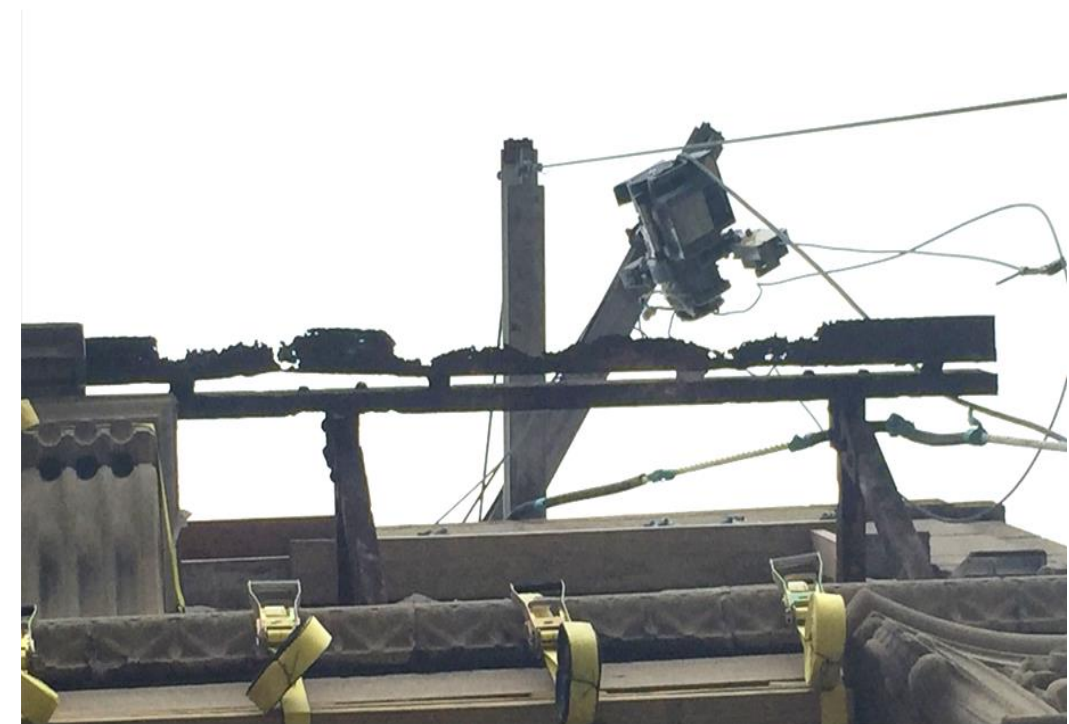
- Exploratory openings exposed severely corroded structural steel members supporting the cornice assembly.
- Structural steel corrosion appeared to be the cause of the observed stone displacement and mortar joint separation.

Views of corroded steel angle for upper cornice gravity support

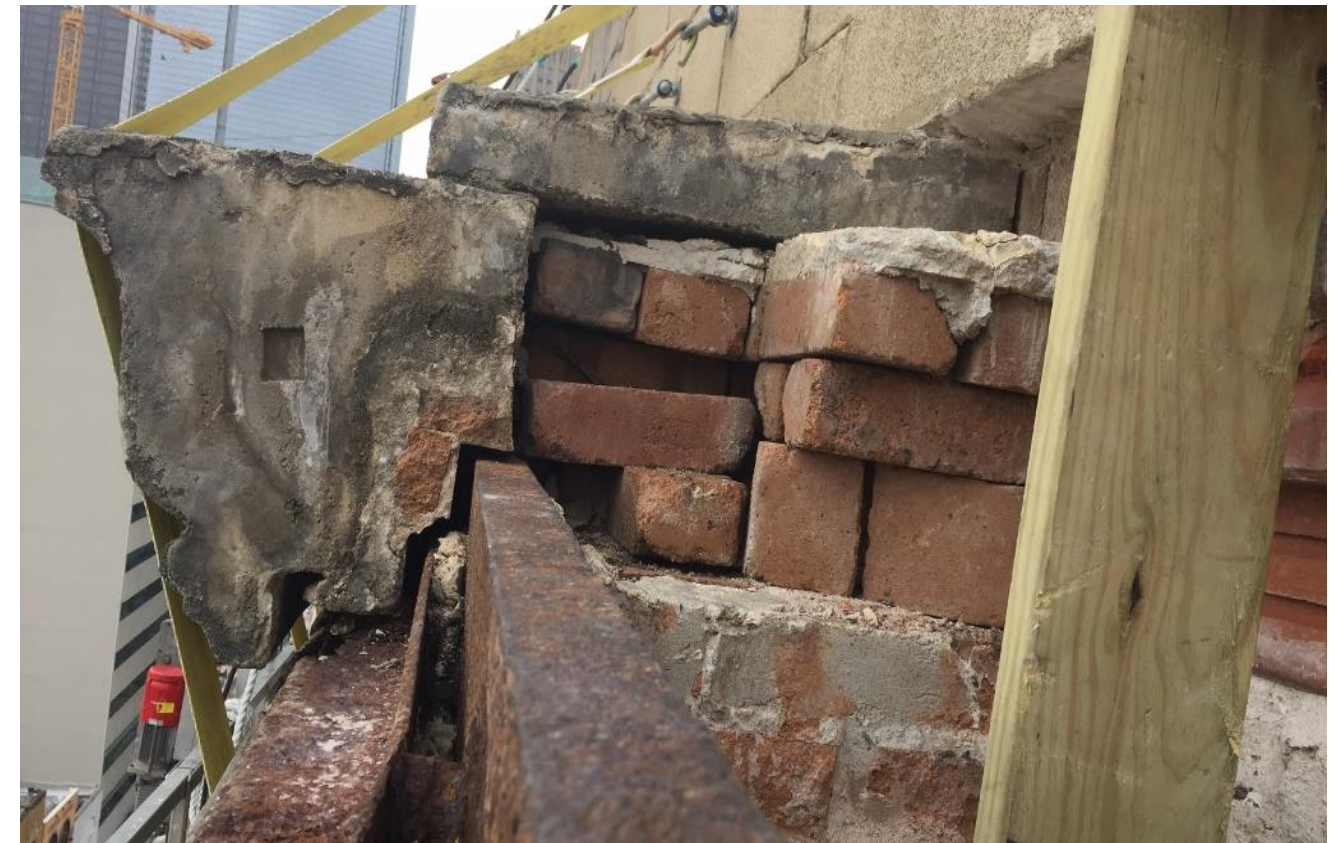
- UngROUTED masonry infill was observed behind cornice stones, likely for transfer of gravity loads from the parapet and upper cornice assemblies to the underlying steel backup framing.

Loose brick infill behind cornice stone

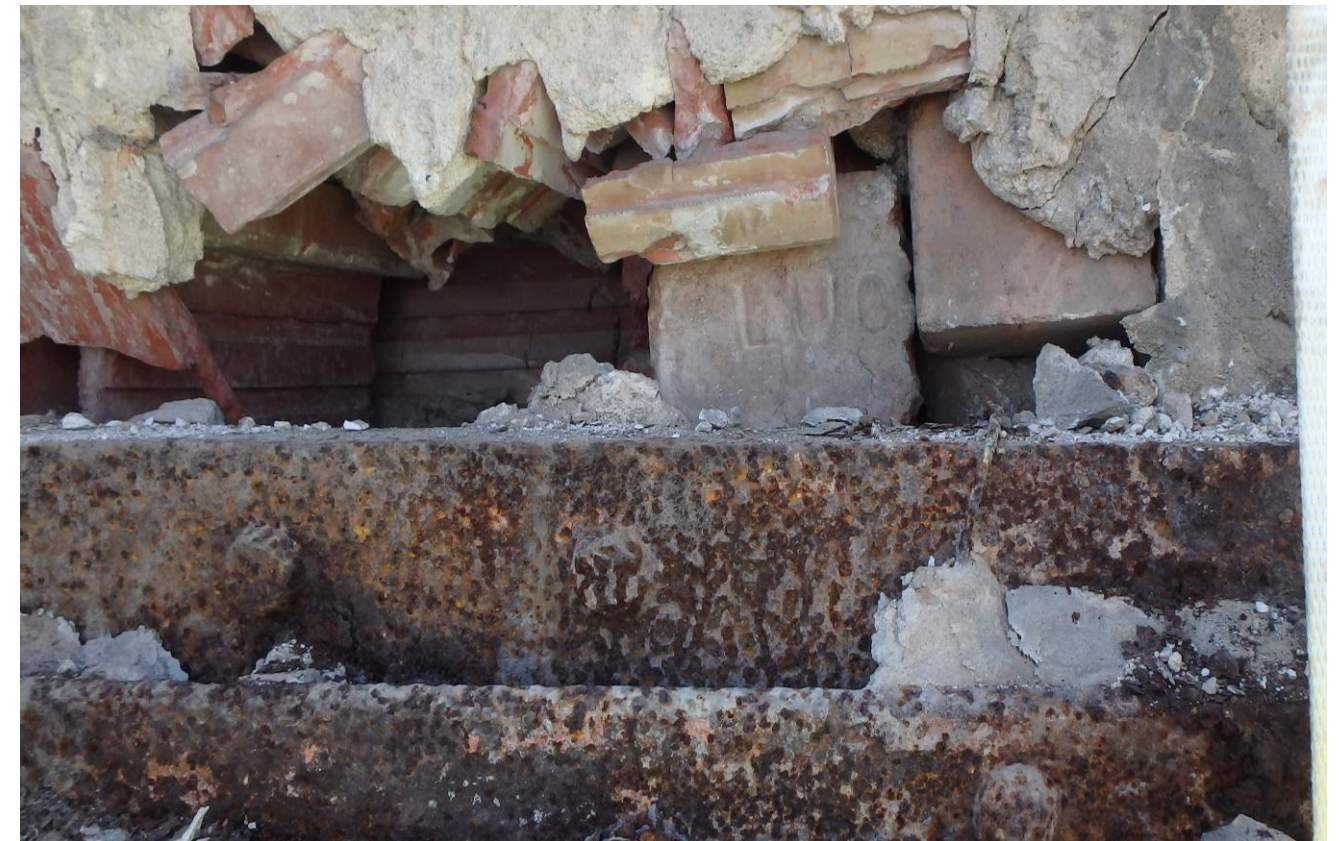
Hollow infill behind cornice stone

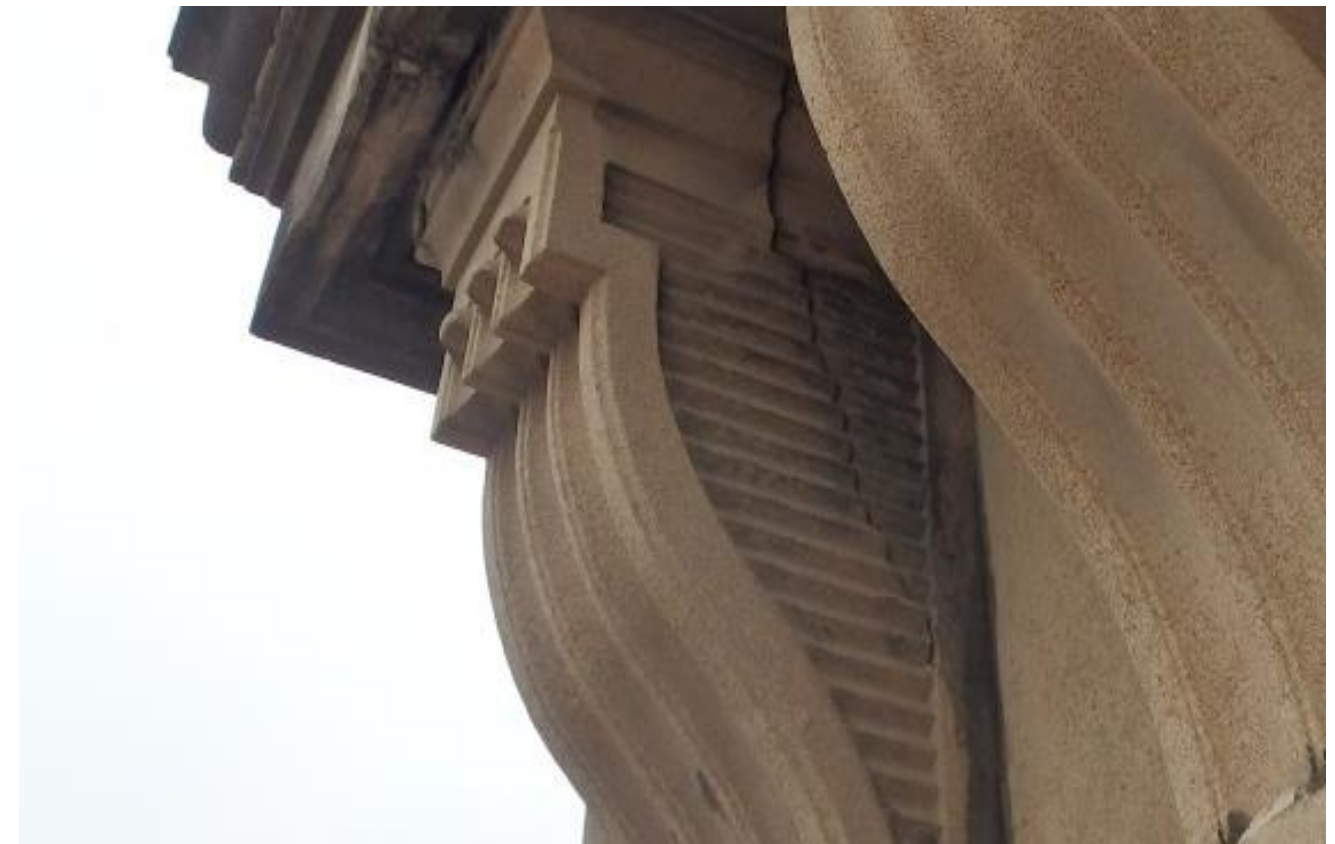
- Approximately half of the cast stone corbels exhibited visible cracking distress caused by expansion forces induced by corroded embedded reinforcing steel.

Cracking distress in the southern most corbel

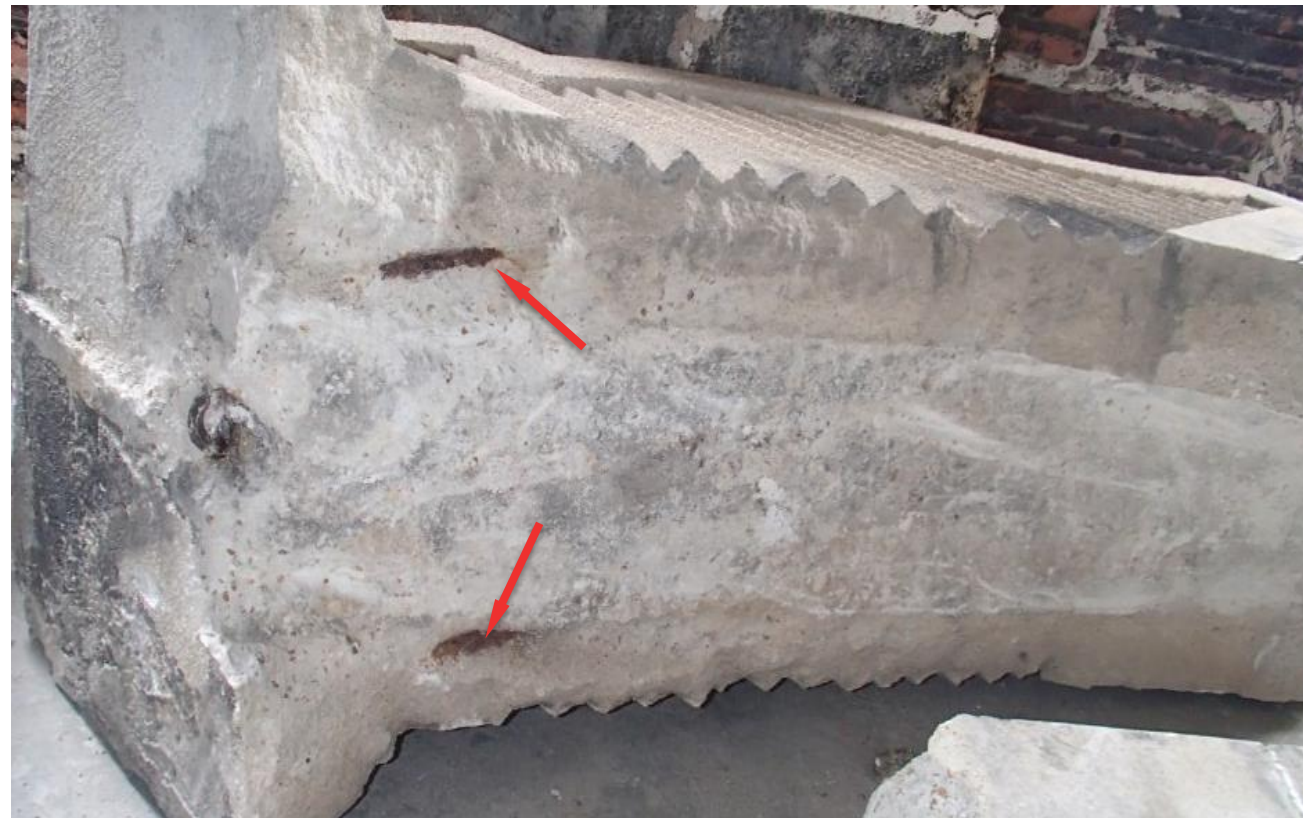
Removed corbel pieces, red arrows indicate corroded embedded reinforcement bars

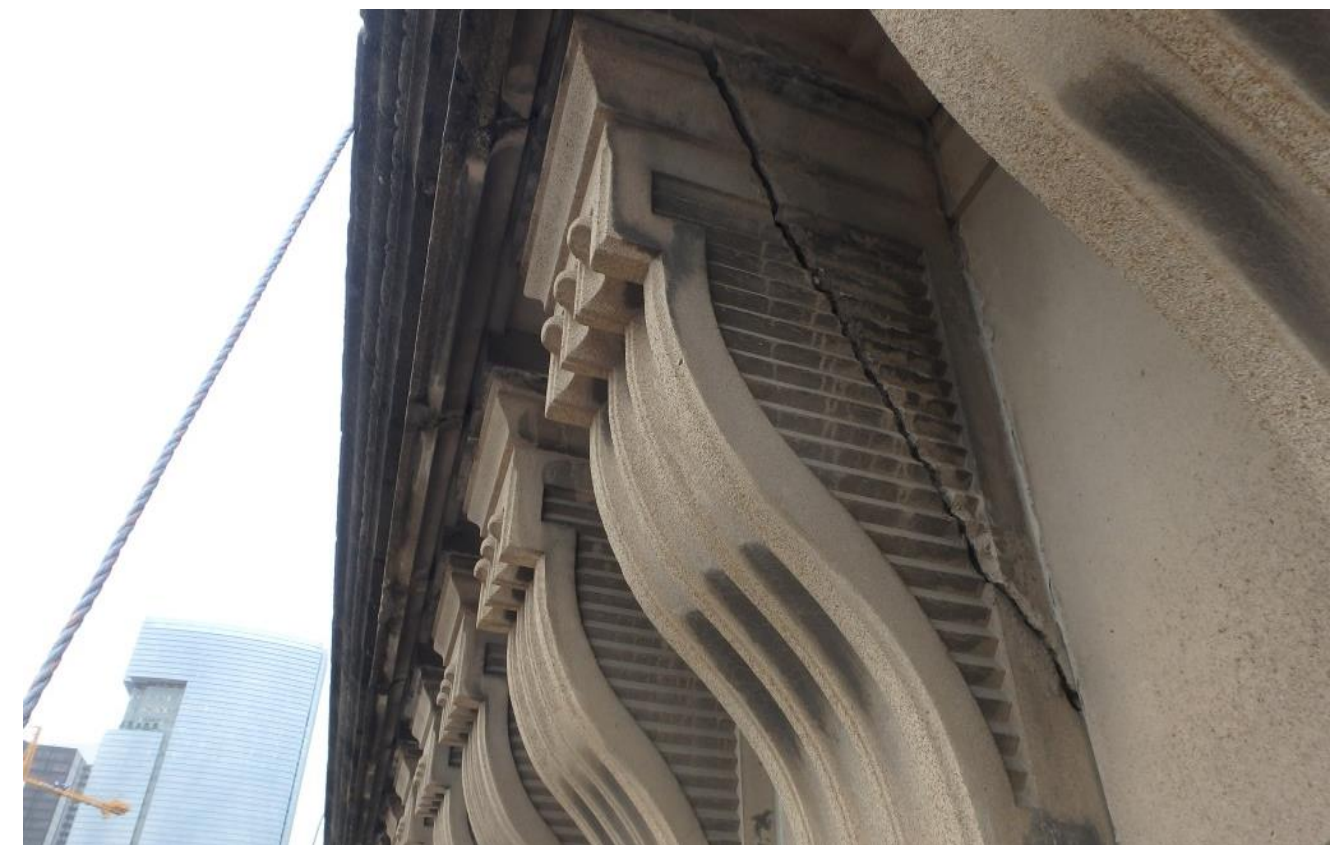
Cracking distress in a typical corbel

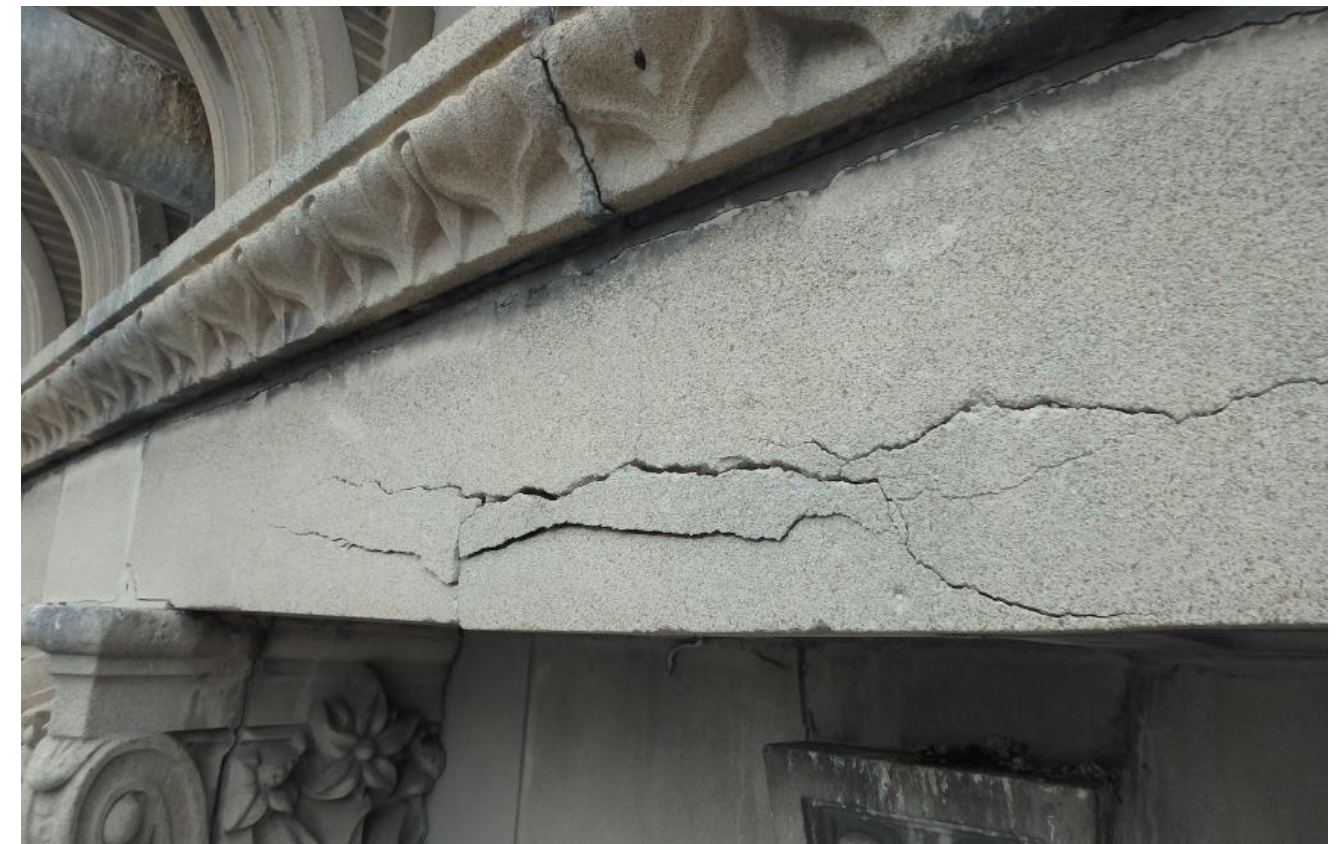
- Cast stone cracking and spalling distress was typically observed at the front edge of the lower cornice members, likely due to corrosion-related expansion stresses.
- Additional cast stone cracking distress, running in a north south direction, was typically observed at the soffit of the lower cornice members.

Cast stone spalling distress the lower cornice

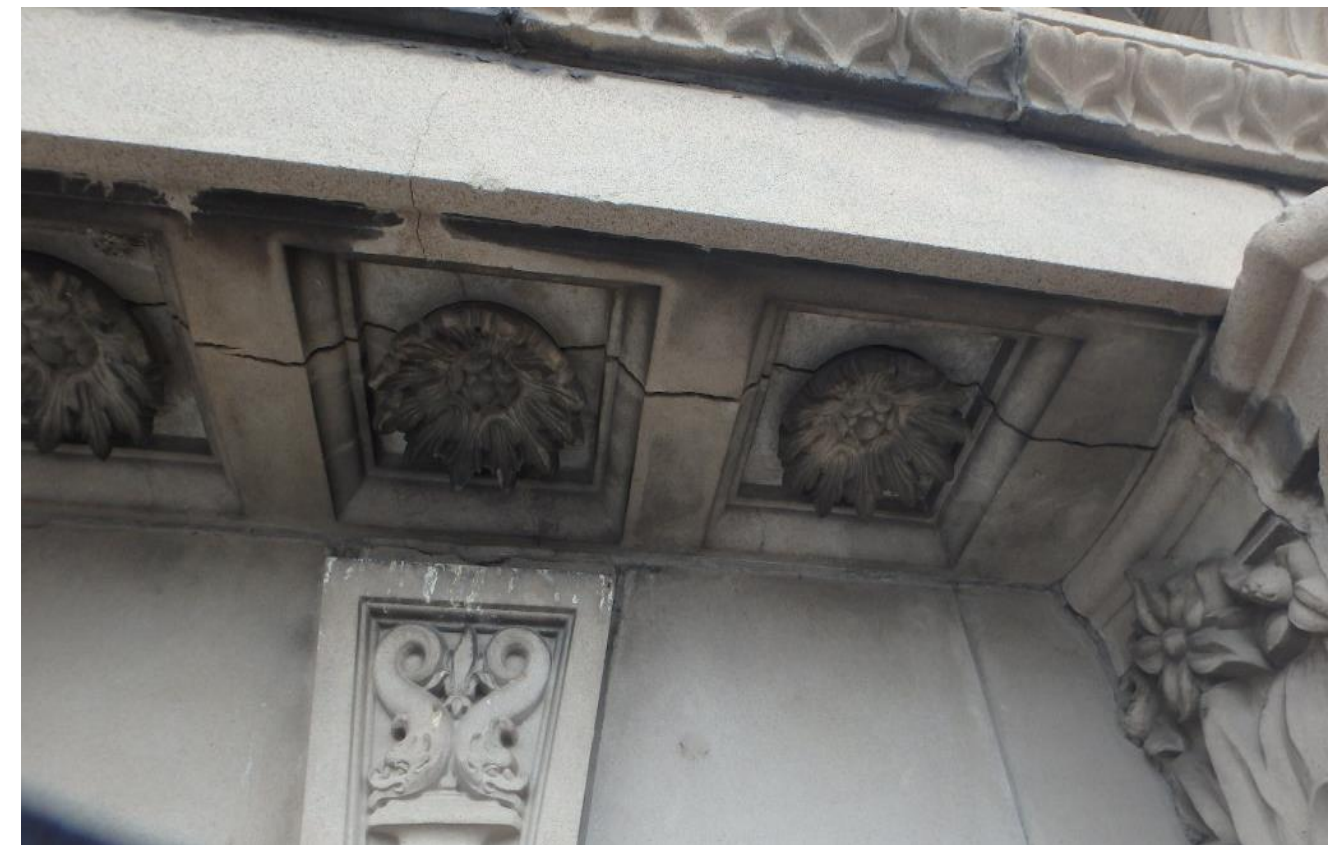
Soffit cracking of the cast stone at the lower cornice

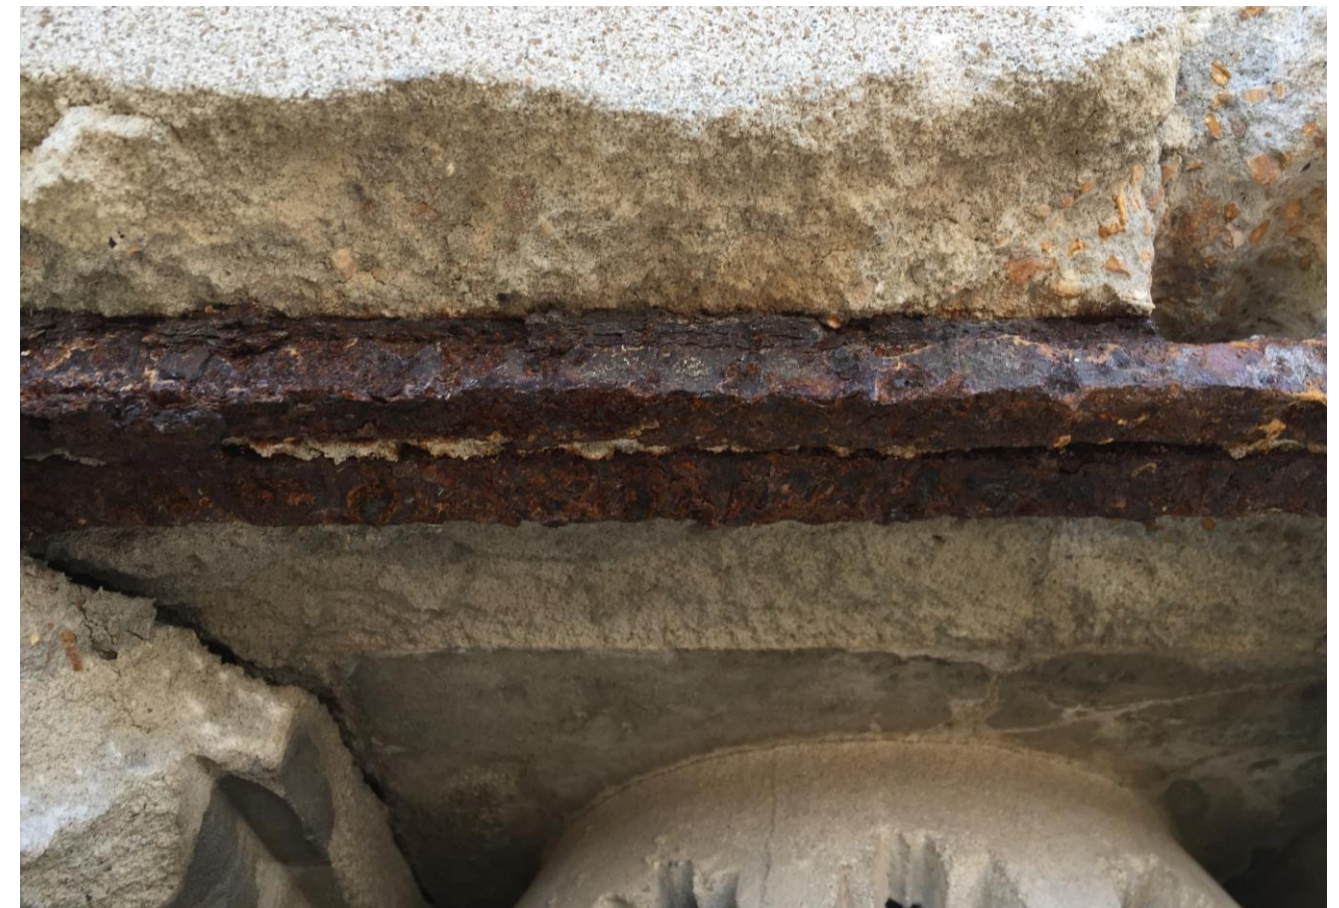
- Exploratory openings exposed severely corroded reinforcing steel bars at the root of the lower cornice front face sections exhibiting cracking and spalling.
- Exploratory openings were not performed at the soffit cracking of the lower cornice cast stone distress due to structural and fall hazards concerns. This cracking is likely due to the presence of corroding embedded reinforcement; however, the distress may be the result of restraint cracking induced by the corbel movement.

Corroded reinforcing steel at front edge of soffit

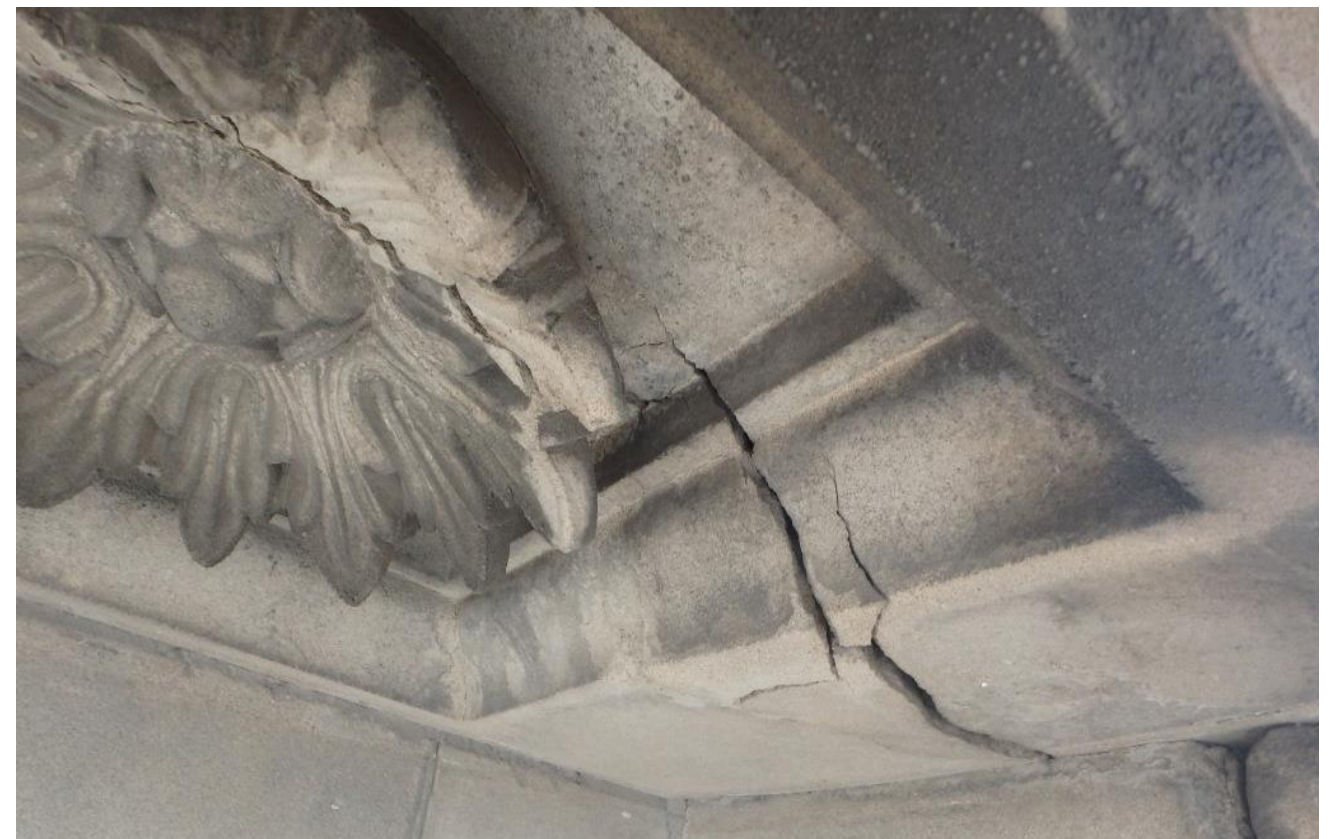
Cracking at soffit overhead surface

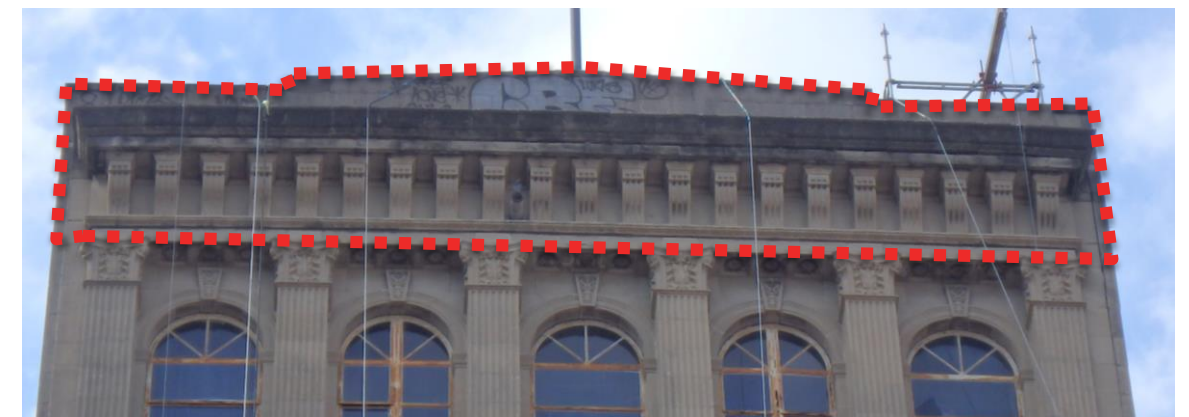
Extents of proposed repair

- Extents of repair limited to east facade, from top of parapet to the soffit of the lower cornice.
- Repair concept requires approval of the Houston Archaeological And Historical Commission (HAHC).
- A lightweight parapet façade recladding system is proposed to minimize loading onto the existing structure.
 - New Structure: New steel framing to connect to the into existing interior steel frame.
 - Existing Structure: Clean, epoxy/intumescent coat, and strengthen or replace as required.
 - Facade: Exterior Insulation and Finishing System (EIFS) with common bond mortar joint engraving to generally replicate existing cast stone parapet pattern.
